GE Frame 5PA Upgrade Motivated by Forced Outage Also Works for 6B and 7B-EA

TTS Successfully Converts a Mark V Fuel Control to Electronic Valves

Article Reprint-Combined Cycle Journal, 2018 Outage Handbook, 2Q/2017

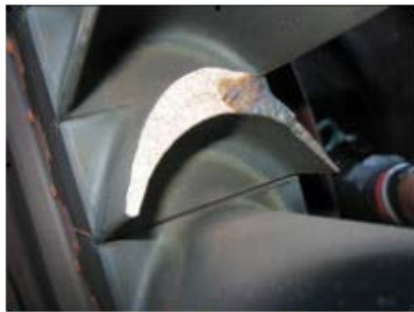
1. Two independent studies traced the root cause of the Row 2 bucket failure to stress corrosion cracking and fatigue

An original Row 2 bucket failed, causing considerable downstream damage. Management decided to begin necessary repairs immediately and to conduct the machine's third major inspection at the same time.

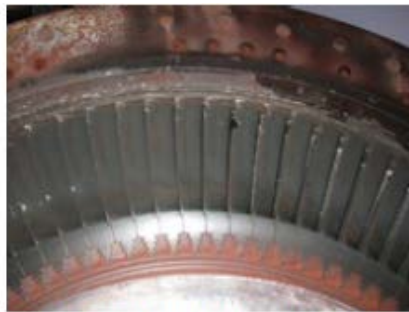
2. Collateral damage from the bucket liberation is in evidence at the trailing edges of the second-stage airfoils

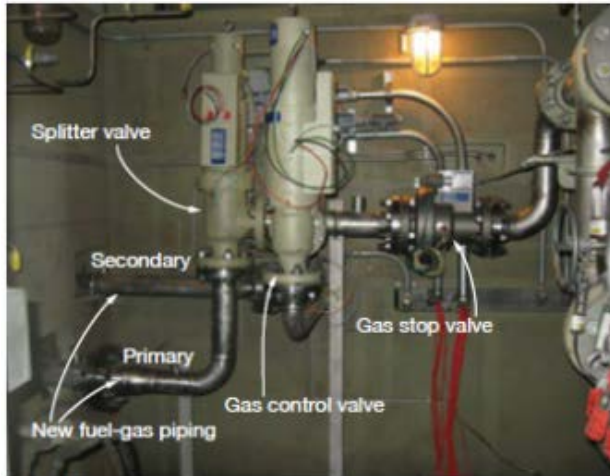
3. A stop valve was required in addition to electronic primary- and secondary-fuel control valves

Turbine Technology Services Corp was retained to remove the liquid fuel system, as described above, and to replace the existing hydraulically actuated, 3-in. SRV/GCV and splitter valves with new electronic valves from Young & Franklin Inc. Existing gas supply strainers and valves were retained inside the compartment. A 3-in. stop valve was required in addition to electronic primary- and secondary-fuel control valves.
