# WORK REPORT

**Customer :** UTE Andasol III

**Project :** Restoring grout on  
footings of a HTF tank

**Equipment:** 31WTE22 BB001 VESSEL  
400 m<sup>3</sup>

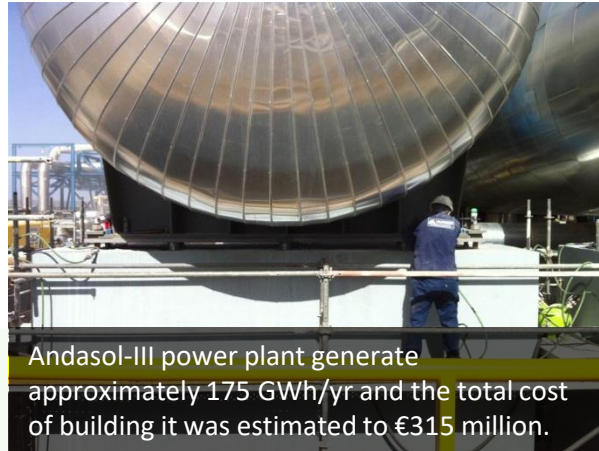
Andasol has a thermal storage system which absorbs part of the heat produced in the solar field during the day. This heat is then stored in a molten salts on two HTF tanks (*Heat Transfer Fluid tanks*).

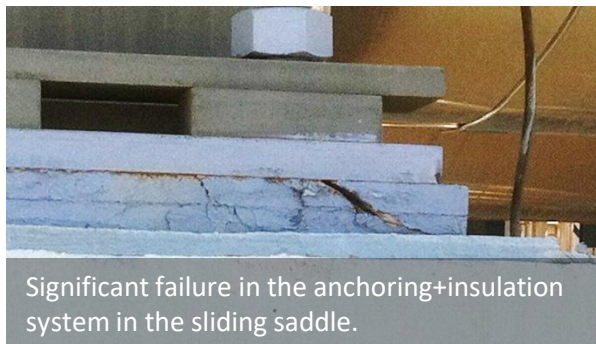
The HTF tanks continuously move slightly due to a contraction-dilatation cycle, originated by its temperature changes, along with great changes in the HTF level which combined, exert considerable loads in the footings.

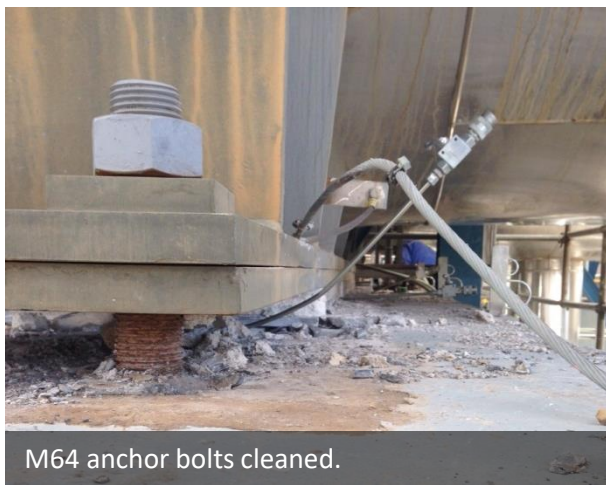
The expansion of the tanks is approximately 2 cm on each side and, adding its contraction, it can have roughly 4 cm of possible movement on each footing.

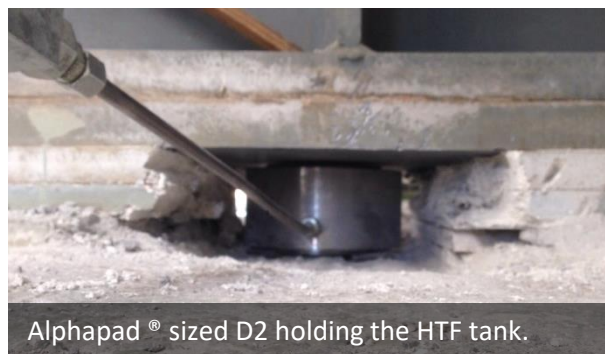
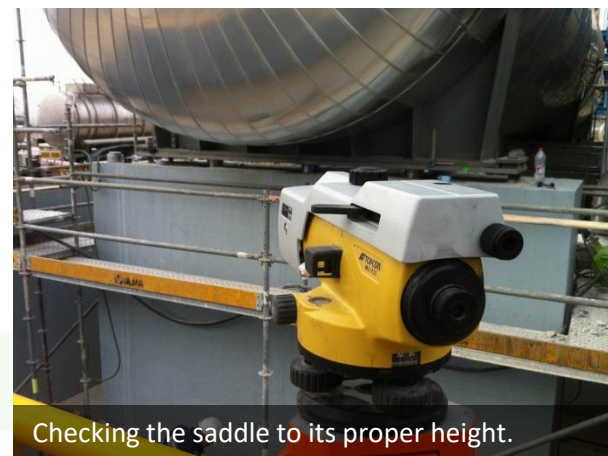
Assuming a friction coefficient for a steel-steel interface  $\mu=0,7$  (usual values in between 0,5 y 0,8) and a net weight of  $P= 170$  tonnes, then  $\tau= Fr/A= P \cdot \mu/A = 0,35\text{MPa}$ .

This calculation doesn't bring into account the effect of *stress-*

*-concentrators* such as sharp corners or defective surfaces.

Any good cementitious grout upholds a shear stress resistance within the adhesion surface of 1.75 MPa, supposed ideal conditions (which slightly differ from in as built conditions). This shear forces, together with a laminated disposition installed without any bonding agent and the loose anchor bolts, was enough to induce a progressive cracking on the isolating material.

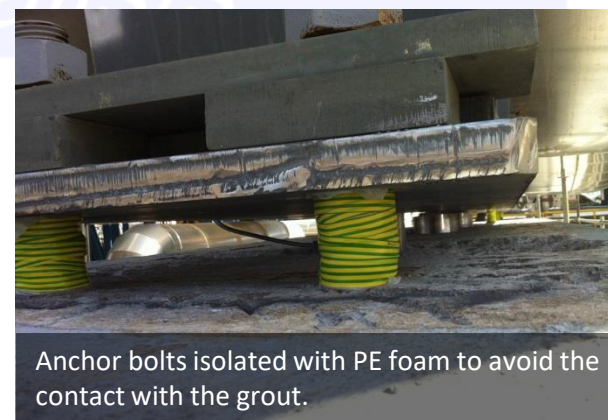
The steel plate and the isolation layers moved conjointly. This fact added dynamic friction to the crack party, degrading further and faster the isolating material.
